USS Princeton (CG 59): Impact of Marine Macrofouling (Mussels and Hydroids) on Failures/Corrosion Problems in Seawater Piping Systems

Dr. Joanne M. Jones and Dr. Brenda J. Little

The First Annual Navy Corrosion Control Workshop

USS PRINCETON (CG 59): IMPACT OF MARINE MACROFOULING (MUSSELS AND HYDROIDS) ON
FAILURES/CORROSION PROBLEMS IN SEAWATER PIPING SYSTEMS

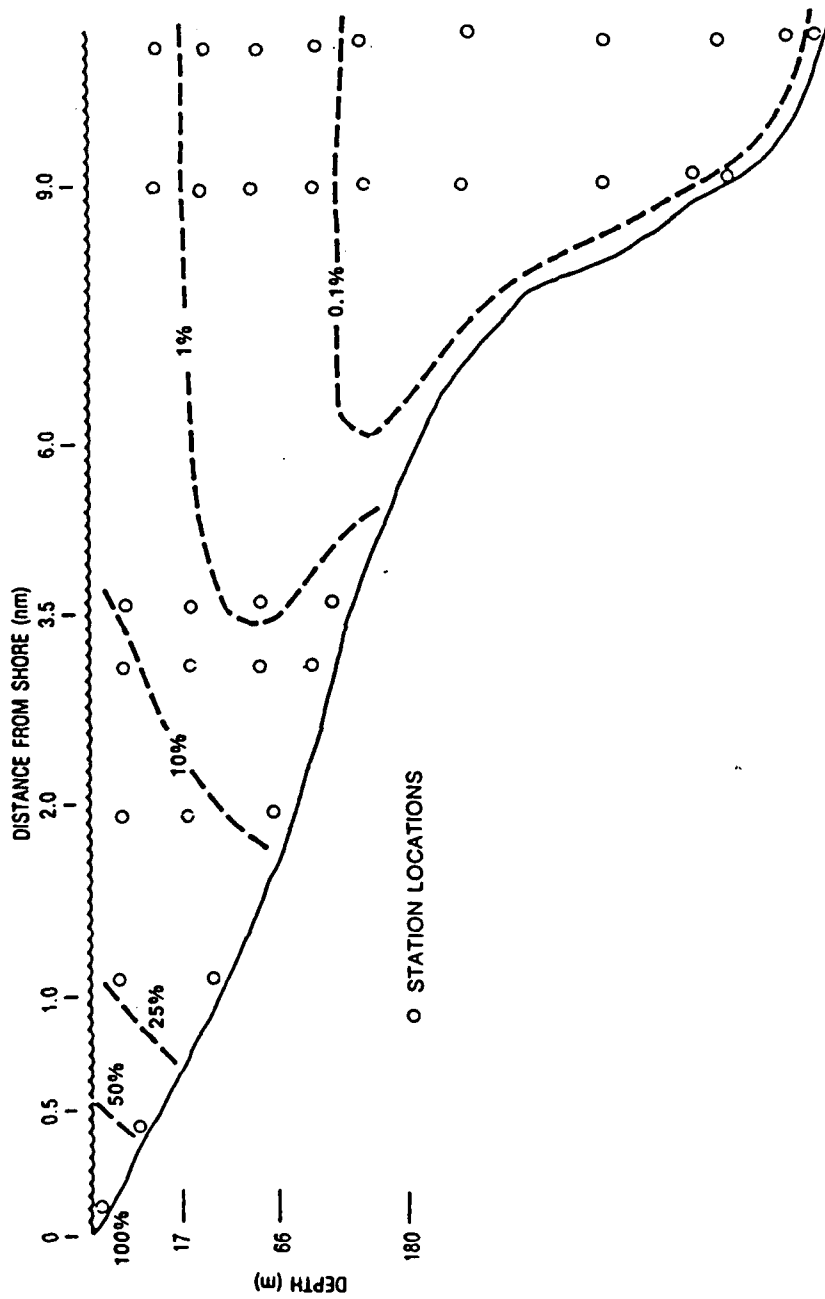
NUMBER OF MYTILUS MUSSELS THAT COULD CAUSE FOULING PROBLEMS
DECREASES WITH THE DISTANCE FROM THE SHORE (FROM LITTLE AND
DEPALMA, 1988)
